FEBRUARY 2021

Georgia B. Williams Nursing Home

Preservation Plan

Ethos Preservation +
Landmark Preservation

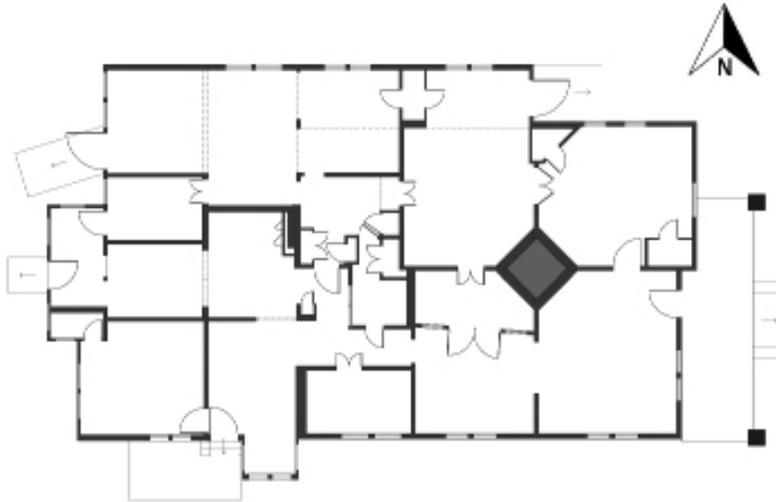
Floor Plan

This snapshot of the floor plan shows the house on its side to include its front porch (right). Note the direction of the north arrow. More detailed plans can be found in the appendix.

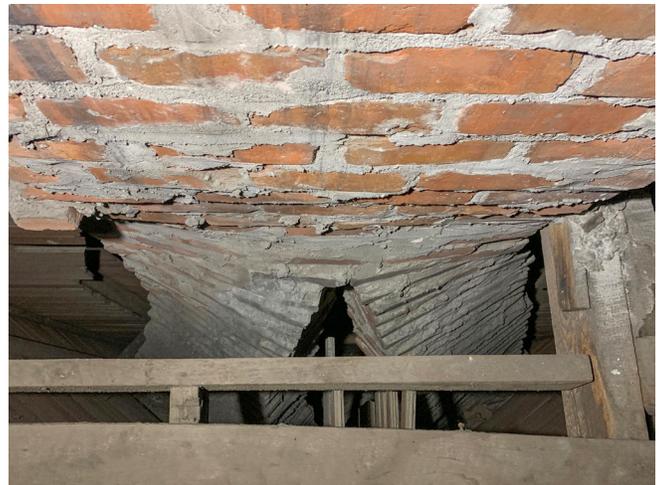
Chimney Legs

When viewed from the attic, the house's central chimney can be seen breaking into four legs at its base. This unusual construction technique likely added greater stability for the central chimney stack, which served four fireplace hearths.

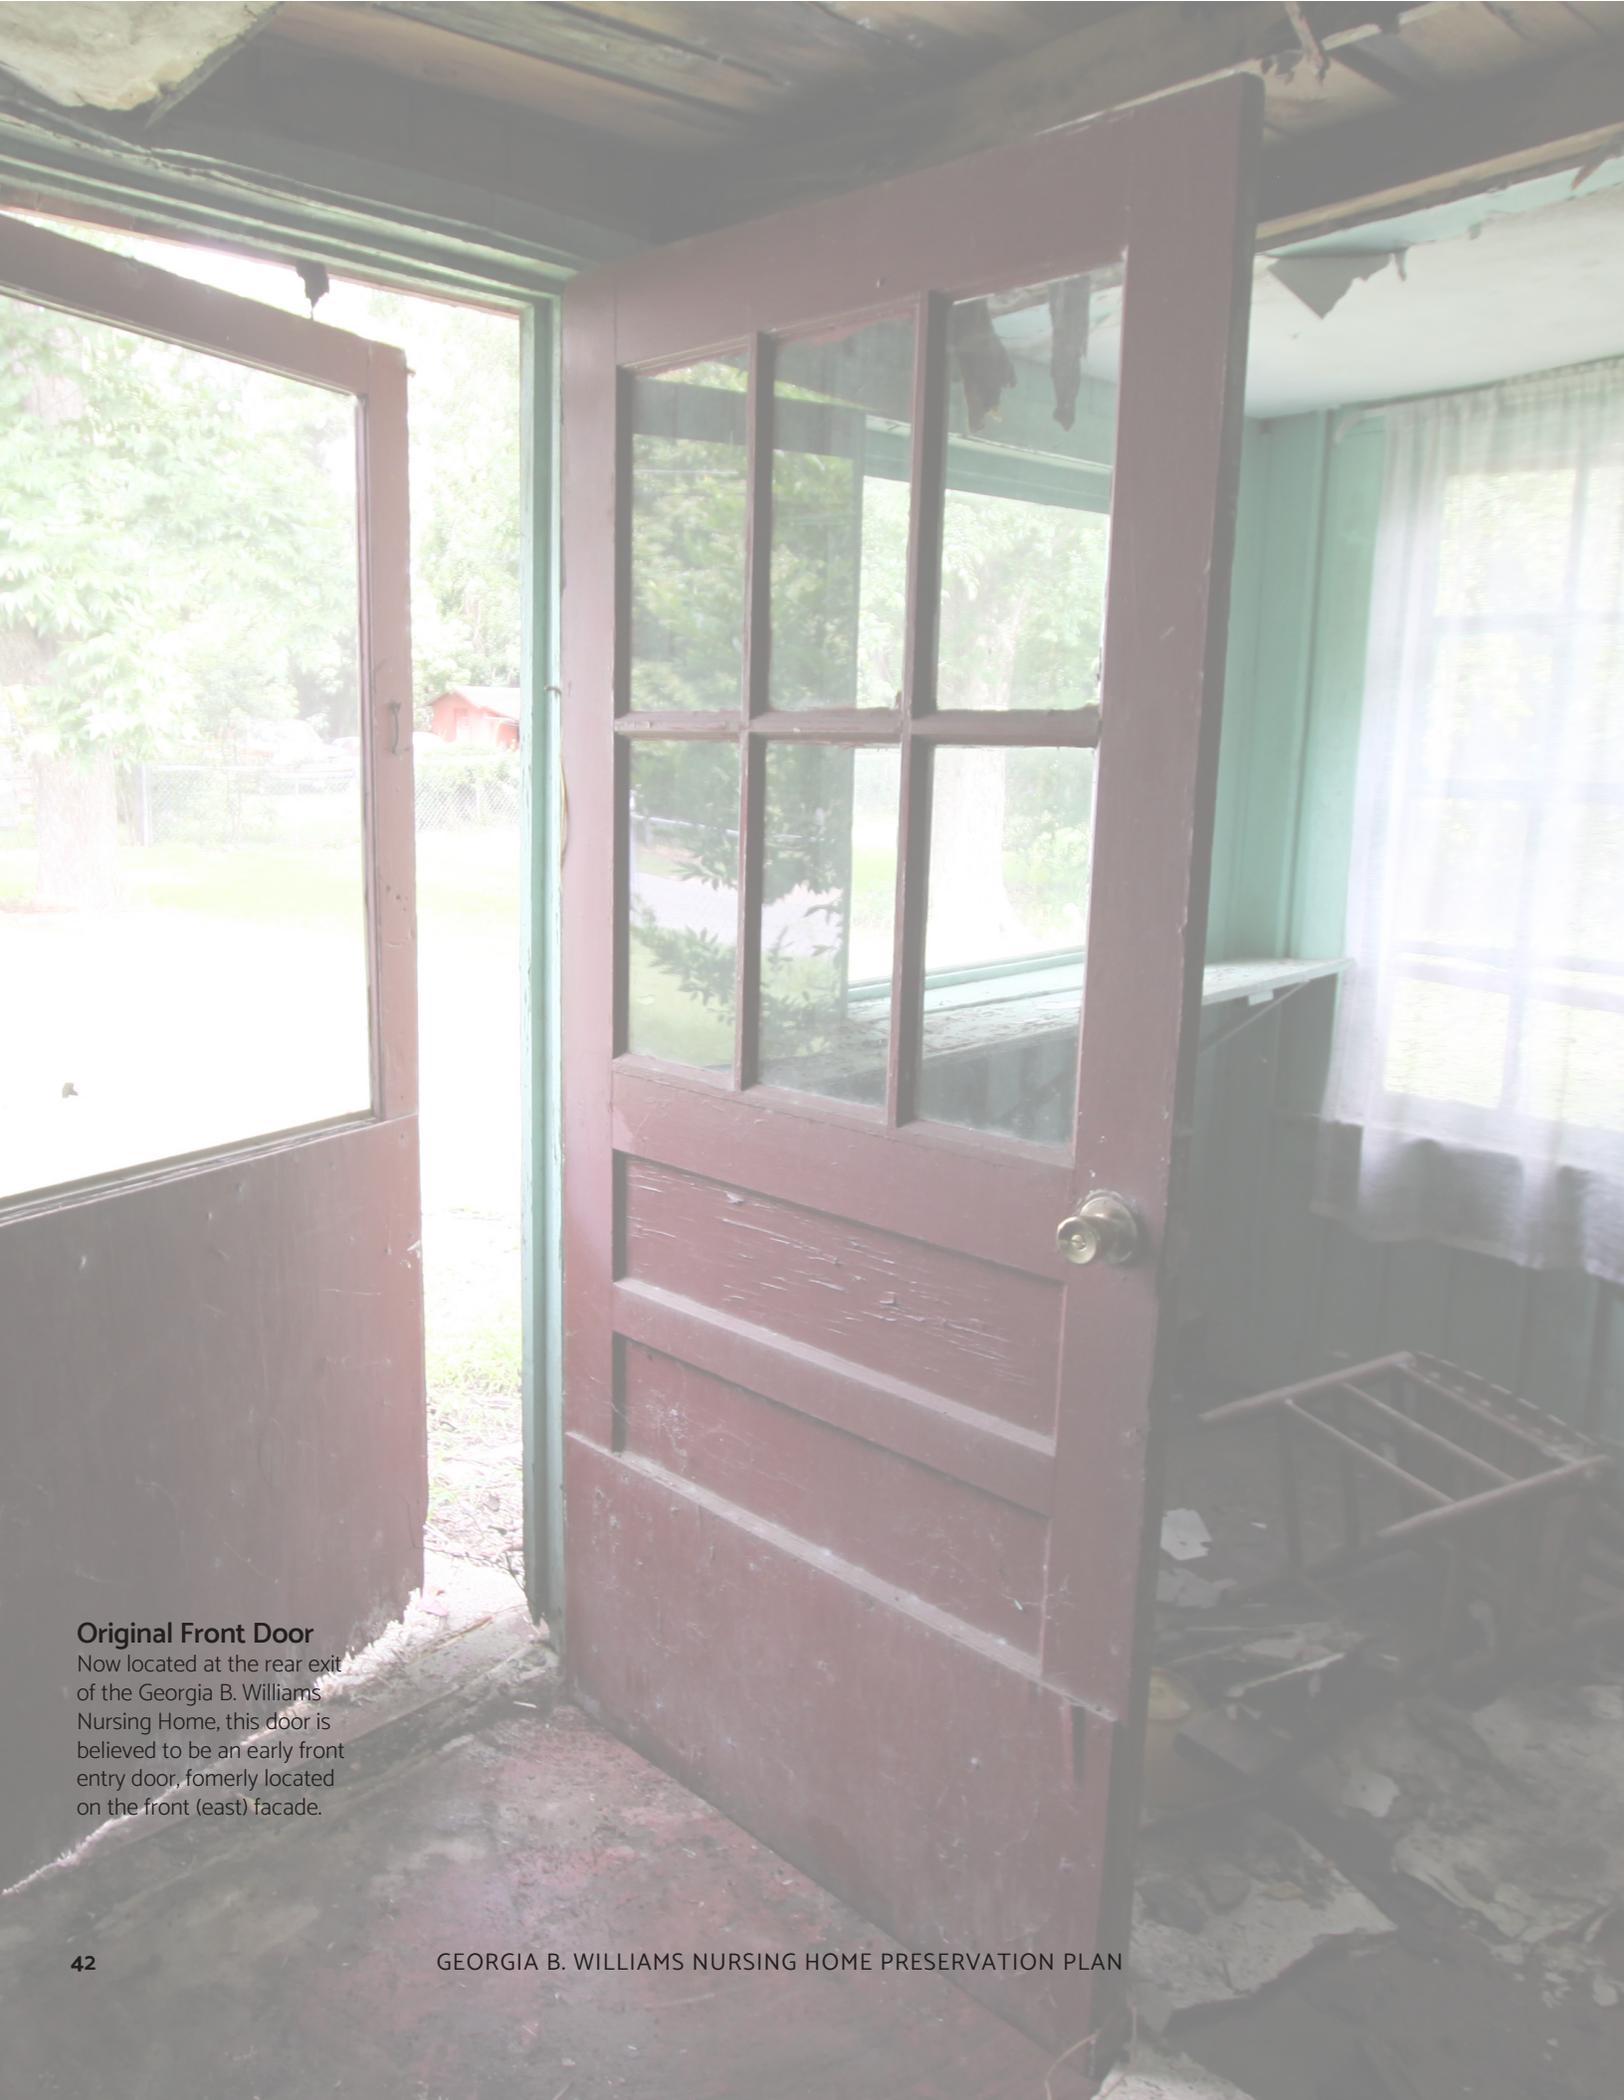
Original Front Door

Now located at the rear exit of the Georgia B. Williams Nursing Home, this door is believed to be an early front entry door, formerly located on the front (east) facade.

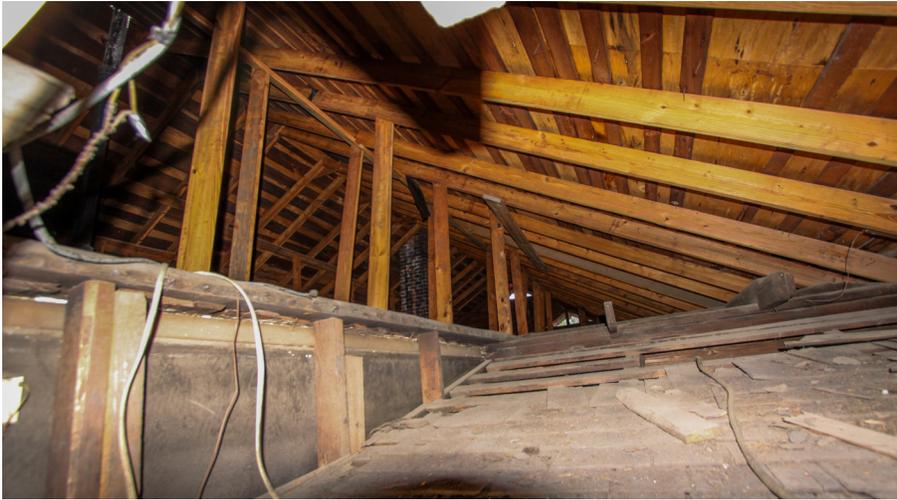
Attic

Accessed from a wall hatch in the Lobby, the attic of the house reveals an earlier wood shingle roof (foreground) and numerous framing members that have been recently replaced.

From within the attic, it is clear that the structure and framing of the ca 1900 and ca 1930 portions of the home are in good condition.

From the interior, it is possible to see that the ca 1940 and ca 1965 portions of the house have structural deficiencies. Also of frame construction, several areas where there are roof leaks have deteriorated sections of wall framing and flooring, to include the deterioration of some door and window framing elements. Degradation is significant and on-going.

- Rebuild portions of the ca 1940 and ca 1965 additions on their existing footprints due to the extent of deterioration
- Perform paint analysis prior to demolition to identify and record original colors
- Ensure new piers are adequately sized and set atop reinforced concrete footers below grade
- Retain doors and windows for reuse whenever possible
- Clad areas rebuilt with a modern-equivalent fiber cement shingle siding
- Frame the rebuilt additions with new asphalt shingle roofing at no less than a 2:12 pitch, with care taken to ensure flashing is comprehensive
- Sister new members to historic members whenever possible

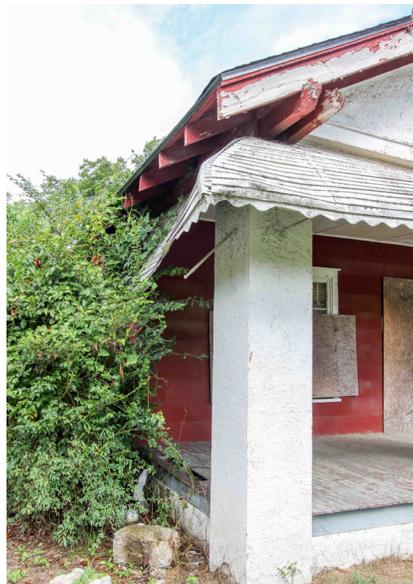
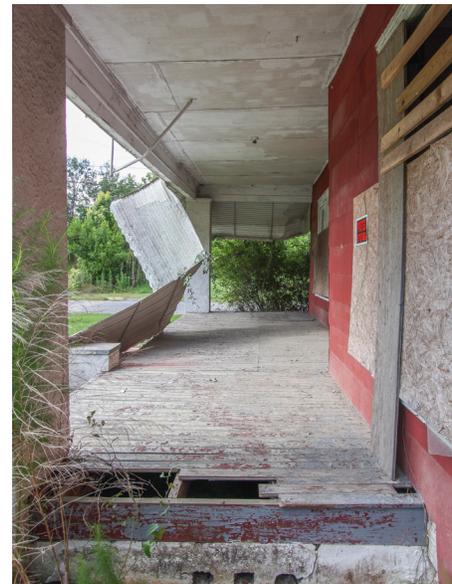
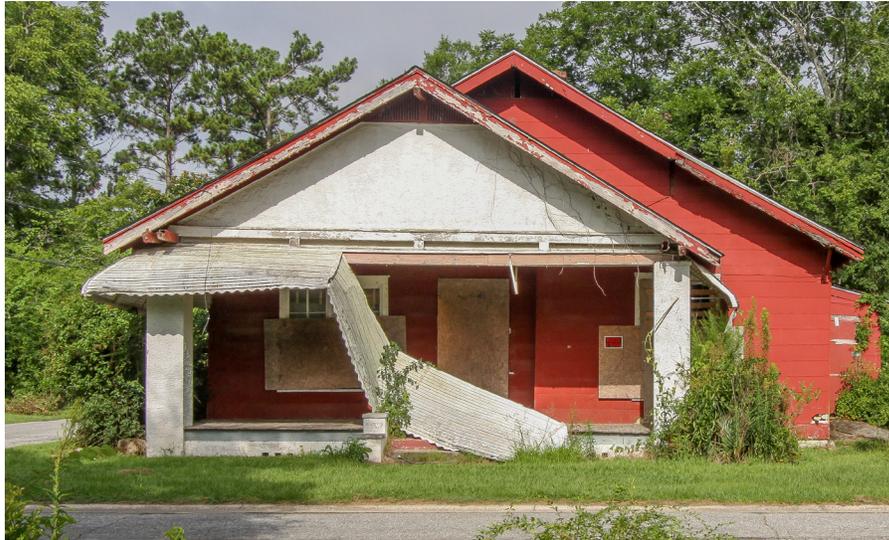
Front Porch

The porch floor has a **wood floor** that is tongue and groove with boards running east-west. Two square sections of the porch floor were replaced at some point, in-kind. Further, a small section of boards are missing at the northeast corner of the porch. The porch was painted at one point, however, little paint remains.

These images show the current condition of the front porch. Part of a major renovation ca 1930, the house was enlarged and converted into a Craftsman bungalow to include this large front gable porch.

The roof edge and soffit, which extend outward to form a wide eave, is also framed in wood. All wood elements associated with the gable end of the porch are in good condition but are in need of paint.

- Retain all elements for repair and reuse. The porch floor and/or the metal awning may need to be replaced in-kind, if too deteriorated beyond repair.
- All elements shall be painted with the exception of the metal awning.
- A simple metal baluster should be installed on the front entry steps to a height of 36 inches to allow for greater accessibility. It is not recommended that a porch railing be installed as it is not required and will create a false sense of historical development.
- Install a new structural lintel in-kind to replace the bowing member. Use the older lintel to perform a paint color match and paint the new member to match.

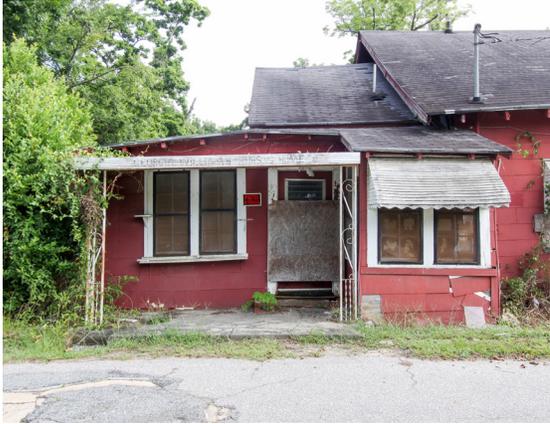
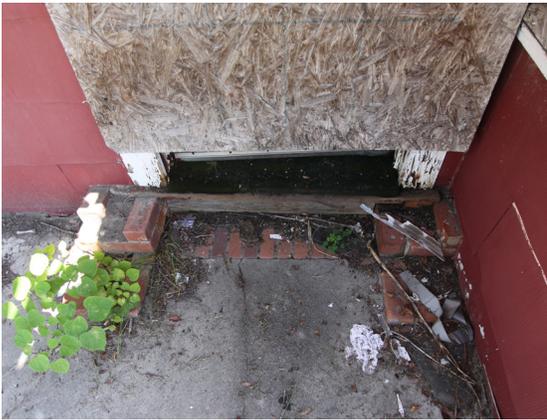
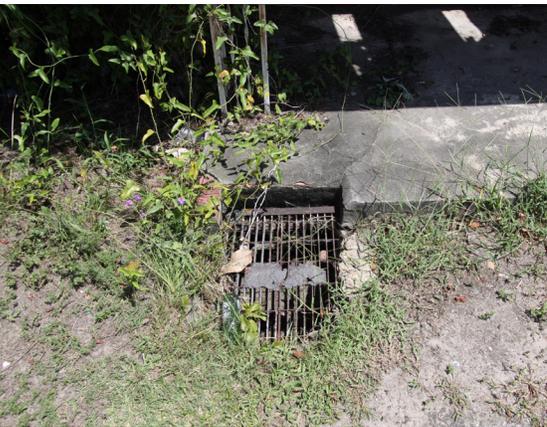
REAR PORCH

In the first two bays of the south facade, facing Beacon Street, sits the rear entry porch that was the main entrance to the Georgia B. Williams Nursing Home. The porch is made up of a rectangular **concrete pad** that is covered by a **flat corrugated metal awning** supported by **wrought iron porch posts**, which have been painted white. The awning retains the ghost of earlier painted lettering which read “Georgia B. Williams Nursing Home.” The concrete pad surrounds an earlier set of **brick entrance steps** placed adjacent to the southern entrance. A handful of bricks are missing, vegetation is present, and the wood sill of the entrance is worn and in need of paint. Situated at the southwest corner of the pad is a sewer drain. At this location, the pad is cut away to accommodate the drain. The rear porch is in fair condition. The concrete pad has experienced some cracking. The metal porch posts and roof have weathered and are in need of paint.

These images show the current condition of the side entrance onto Beacon Street. The entrance is set within the house’s rear addition, which was built ca 1940 and altered ca 1965.

- Replace missing bricks at entrance steps in-kind and install simple metal baluster at a height of 36 inches
- Repair wooden door sill, with replacement in-kind if necessary, and paint
- Repair cracks in concrete slab or pour new slab in-kind
- Assess the structural stability of the entrance awning and retain and preserve existing awning, if possible
- Paint porch posts and repaint ghost text on awning edge to read “Georgia B. Williams Nursing Home”

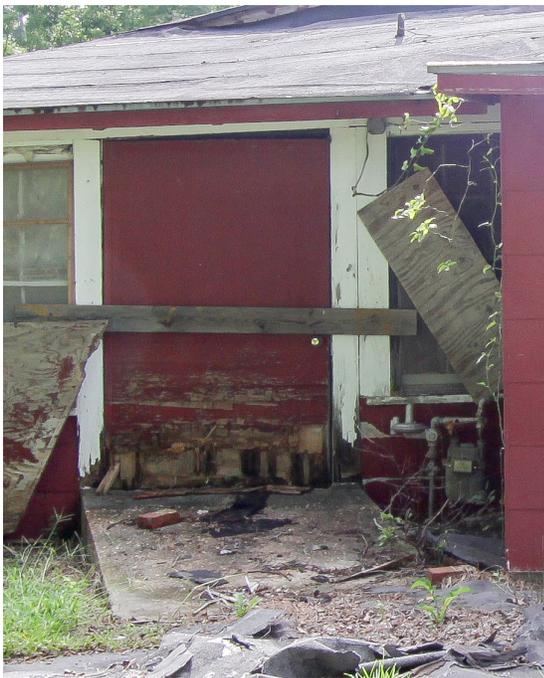
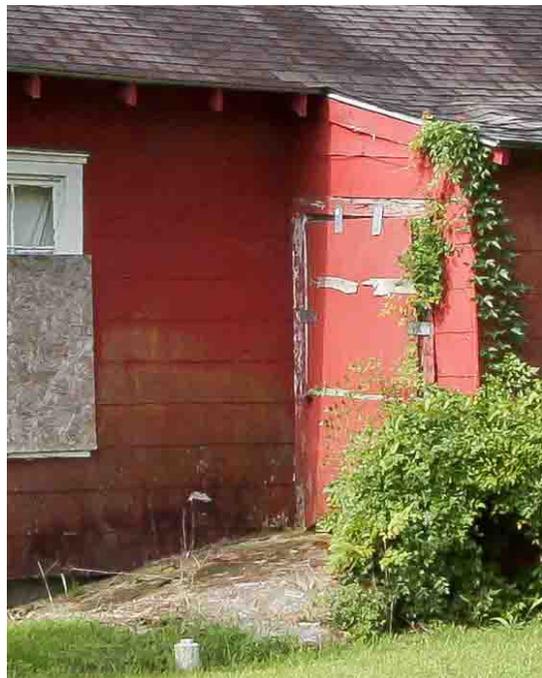
Ramps

Three **concrete ramps** were installed, the first of which was added ca 1940, to allow for accessibility at three secondary entrance points. These entrances enter into Recovery Room A, Recovery Room B, and the Back Porch, which has been enclosed. The ramps are in good condition but do not have balusters of any kind.

Pictured here are two secondary entrances that were added to the GBWNH when additions were built. Added specifically to accommodate wheelchairs and gurneys, they have low sloped concrete ramps that lead to extra-wide entrance doors.

- Retain sloped concrete entrance ramps
- It is recommended that any ramps used for life-safety egress receive a simple metal baluster to a height of 36 inches

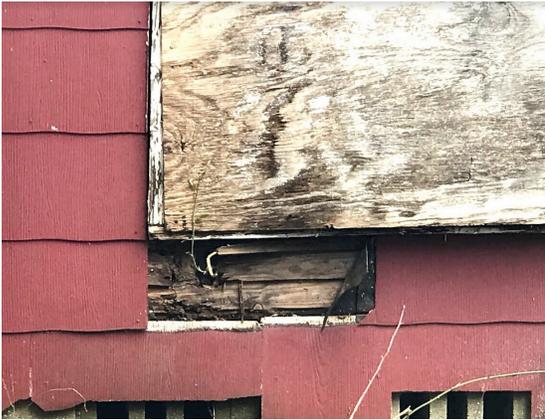
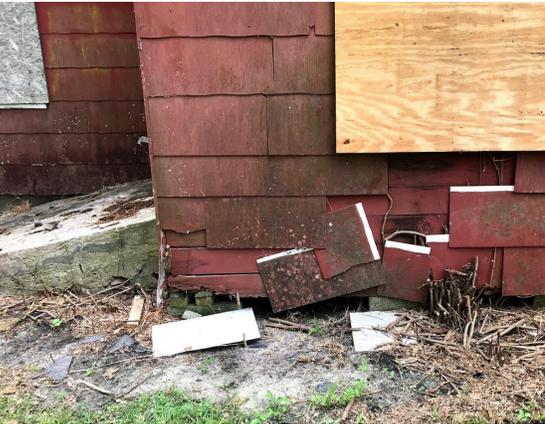
Pictured here are several areas where the house's asbestos shingle siding has broken or been removed to reveal a variety of clapboard siding beneath. The first image (top) also shows the house's original exterior pink paint color.

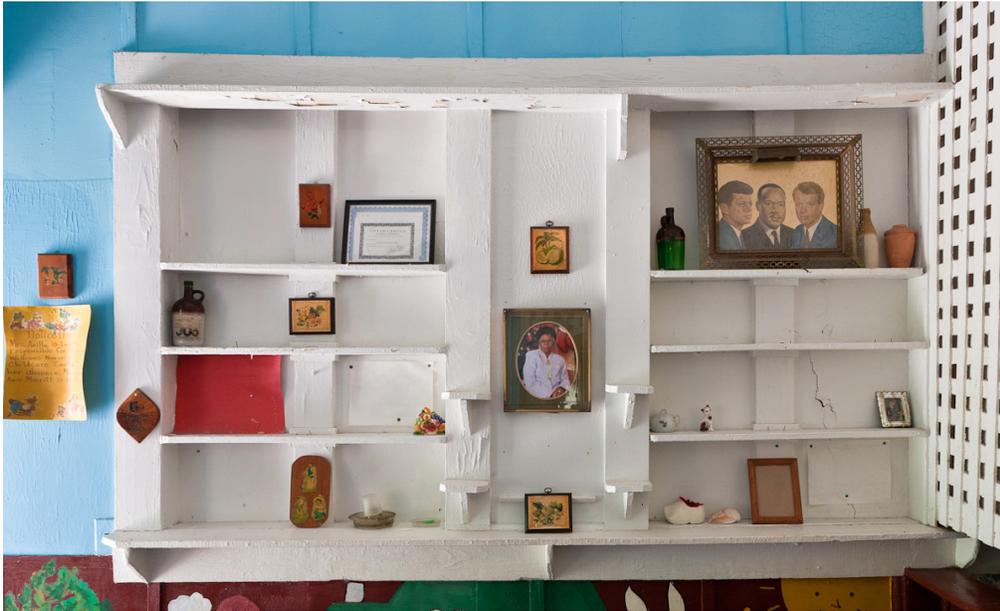
Repurposed Window Opening

This image from the National Register nomination shows the west wall of the Lobby. Previously an exterior wall, the window opening in this location has had its sashes removed for conversion to interior shelving.

Because the house has multiple additions, there are places where windows have been incorporated into interior areas, such as along the west wall of Bath B and along the west wall of the Lobby, although these windows in this location no longer remain (above). It is believed that the four-over-four windows incorporated into the exterior walls of the additions were originally part of other, earlier, exterior walls.

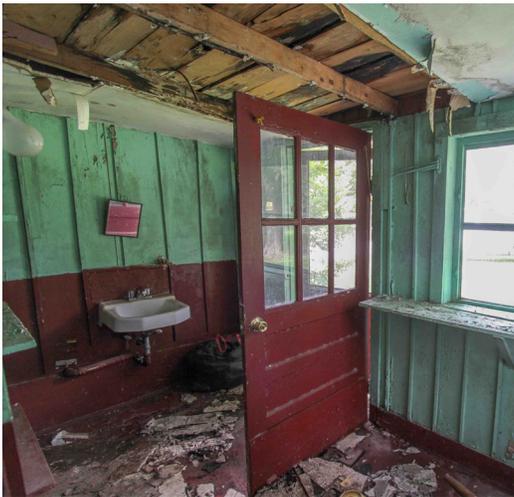
Original Entry Door

The house has five entry and exit doors that are unoriginal to the house, however, many were added during the house's period of significance. Both the main entrance to the house and the main entrance to the Nursing Home off of Beacon Street are **solid wood doors** with central glass openings filled with jalousie windows added ca 1965. Prior, the front entry door was a three-panel wood door with a six-light inset window. This door was relocated to the rear of the house, when the rear porch was enclosed (left).

Set in the background of a photograph ca 1960, the house's original front entry door can be seen. Additionally, the house's earlier, lighter, paint color is visible in this black and white image. It is believed that this door was repurposed as the rear exit when the Rear Porch was enclosed after 1965.

- Retain all extant window openings and sashes for reuse whenever possible
- Complete a window assessment to determine which windows need new glazing, weatherstripping, and/or other in-kind repairs or replacement
- Paint all windows, with consideration for their continued use and operability whenever possible
- Replace windows too deteriorated for salvage in-kind to match with true-divided light wood windows of the same size and configuration
- Retain the three main entry and exit doors for reuse, repair as needed, and paint
- Replace the plywood doors with a period appropriate single or pair of solid wood doors fit to size each opening

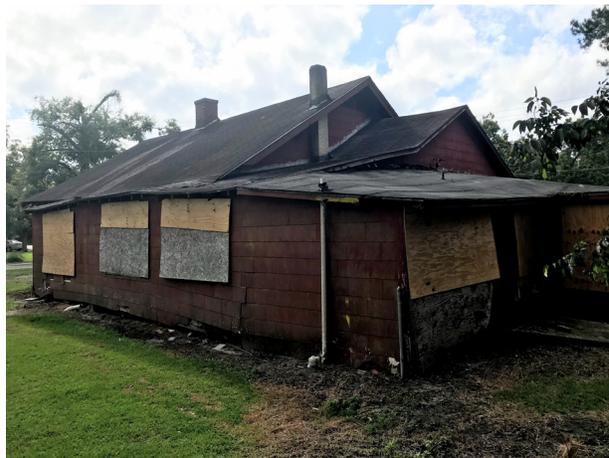
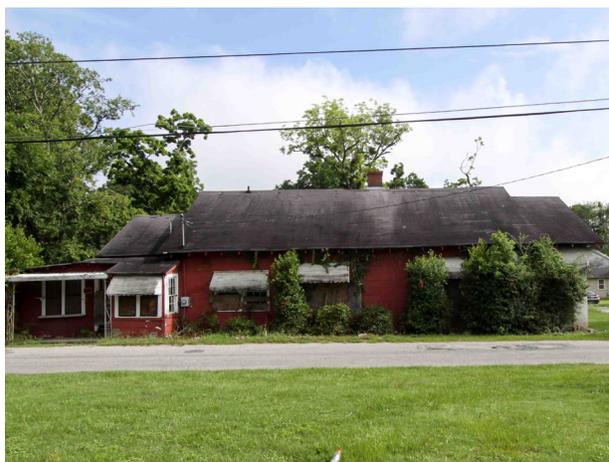
Roof and Chimney Variations

The house has two **brick chimneys**, both of which are in good condition. The chimney piercing the ridgeline of the roof is the older of the two and is original to the house. The smaller square chimney was installed as a wood stove flue.

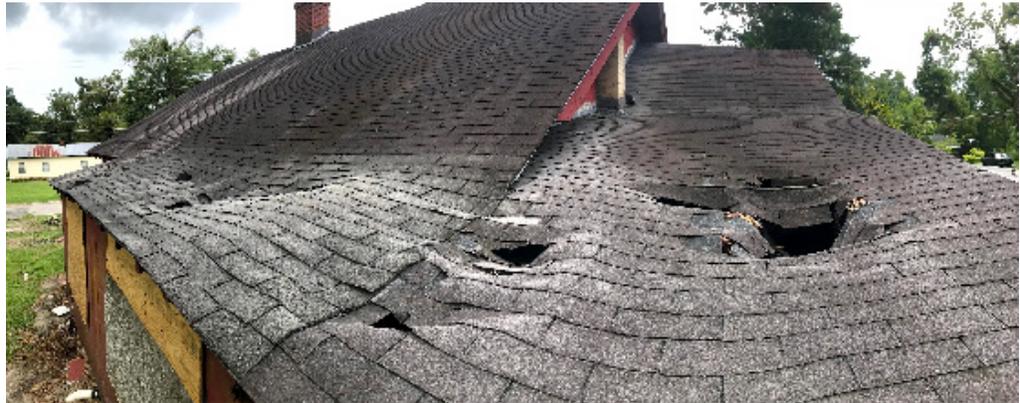
This image was taken at the house's northwest corner, as viewed from a ladder. The image shows the state of the low-pitch roof associated with the north addition to include many holes.

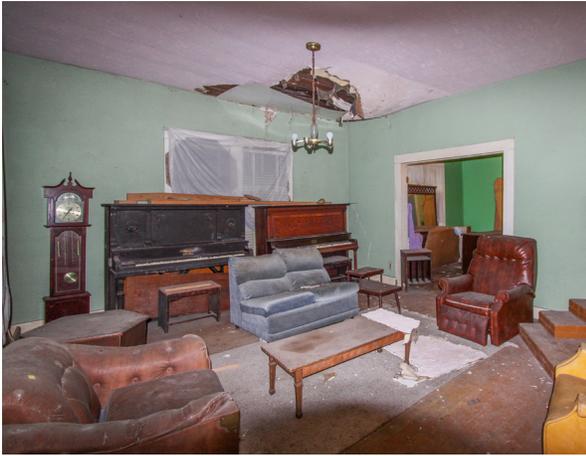
Living Room

The living room is located at the southeast corner of the house and is square in shape with the exception of a corner hearth. The room has a **wood floor**, which has been stained, **plaster walls** and a **sheetrock ceiling**. The walls and ceilings are built of tongue and groove wood boards with plaster laid over top. The paint color dates to the period of significance as revealed in historic photographs (right). It is likely that when the house was built all of the walls and ceilings were exposed tongue and groove boards.

(Above) Images of the current condition of the Living Room. Note ceiling hole and corner hearth.

- Clean and stain the floor to match the original floor stain
- Paint the walls, trim, doors, and windows to match existing colors, as needed
- Patch the sheetrock ceiling in-kind and paint to match
- Retain ca 1940 hearth as-is and paint to match
- Retain historic light fixture at center, clean and repair for reuse

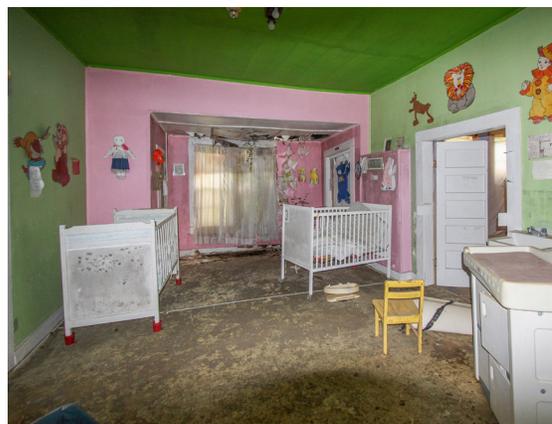
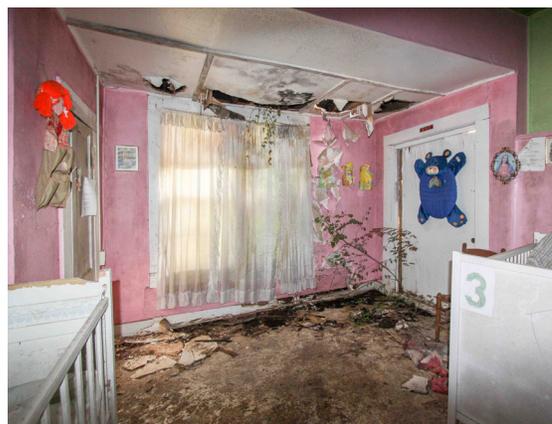
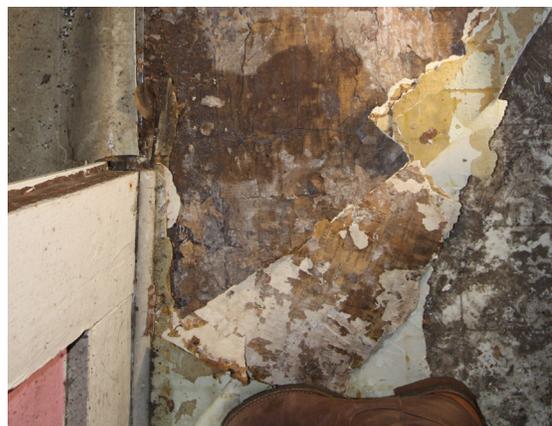
Recovery Room A Current Conditions

(Above) Images of the current condition of Recovery Room A. Last image shows historic newspaper flooring underlayment.

The room has **plaster and sheetrock walls**, dependent on era, that are in good condition but are suffering from hairline cracks and peeling paint. The room's most recent coat of paint is believed to have been added when the house was converted for use as a daycare. The room has **wood baseboards** and **window and door trim**. A wall mounted porcelain **hand sink** exists on the east wall, with a small section of **wall tile** above, which has been painted to match the wall.

While the majority of the space is in good condition, the portion of the room that is associated with the addition has suffered the most damage, originating from a roof leak which is now bringing daylight and vegetation in. This has resulted in the rotting of several floor joists below.

- Rebuild the addition to the north in-kind, to include the removal of all elements that have experienced rot. Sister new framing elements to historic elements wherever possible
- Restore wood floors or replace existing vinyl flooring in-kind with a sympathetic and period appropriate modern-equivalent vinyl flooring
- Restore the earlier fireplace mantel and fire box
- Paint all walls and wood surfaces
- Retain hand sink and remove paint from associated tile
- Retain light fixture and repair for reuse

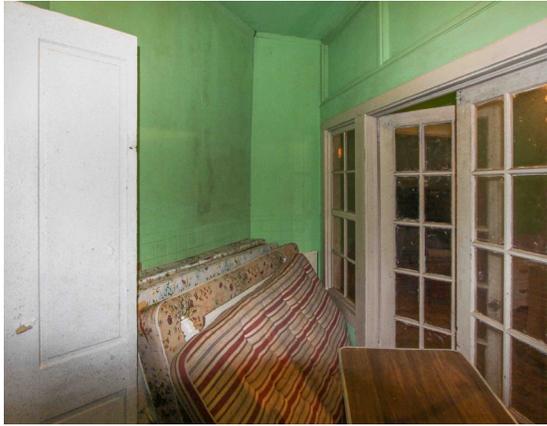
Incubation Room

(Above) Images of the current condition of the Incubation Room. Note hearth with no fireplace (left) and variation in wall construction (wall inserted on right).

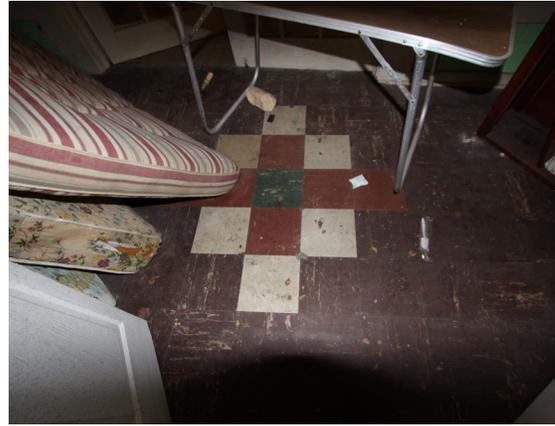
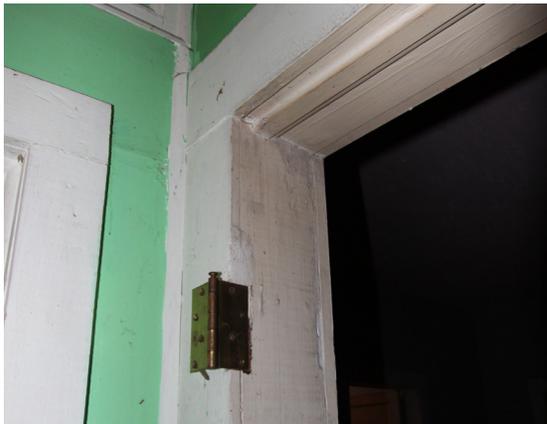
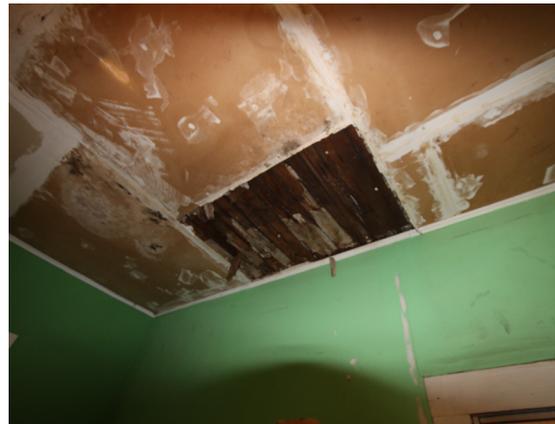
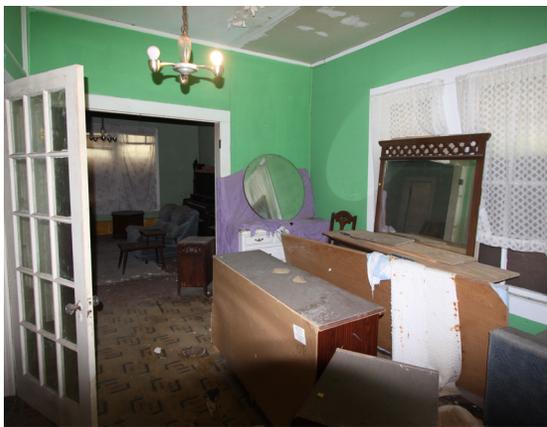
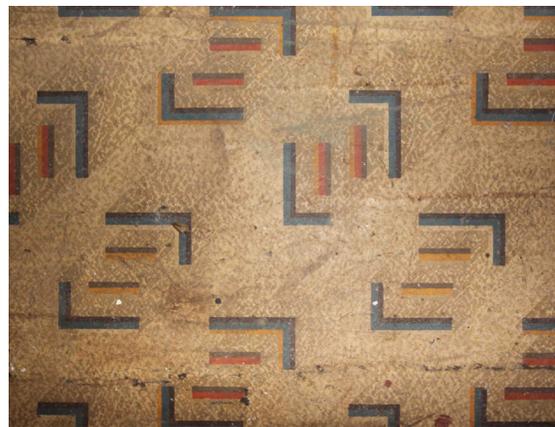
Dining Room

(Below) Images of the current condition of the Dining Room. Note ceiling patch exposing tongue and groove boards, hardware for moved French Doors, and "cork" linoleum floor.

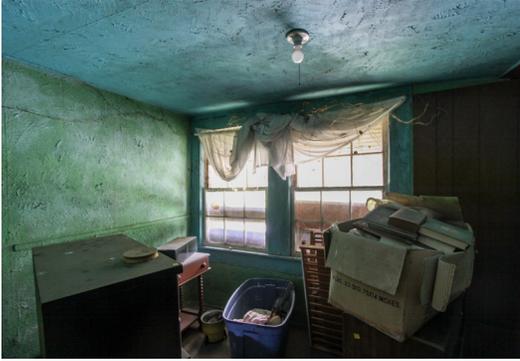
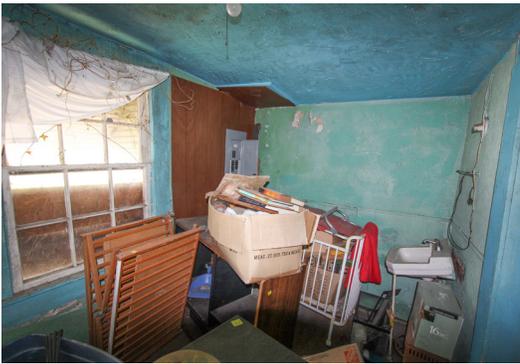
Bedroom C Current Conditions

(Above) Images of the current condition of Bedroom C. Note the low ceiling and vegetation that has entered the room at the window opening.

- Examine flooring after the removal of all stored items and repair or replace in-kind
- Remove vegetation and repair windows to ensure they are air and water tight
- Remove wood veneer wall patch, examine and repair plaster, and paint
- Paint all walls and wood surfaces
- Repair wall mounted sink, adding structural wall support internally as needed
- Retain lighting configuration for period interpretation

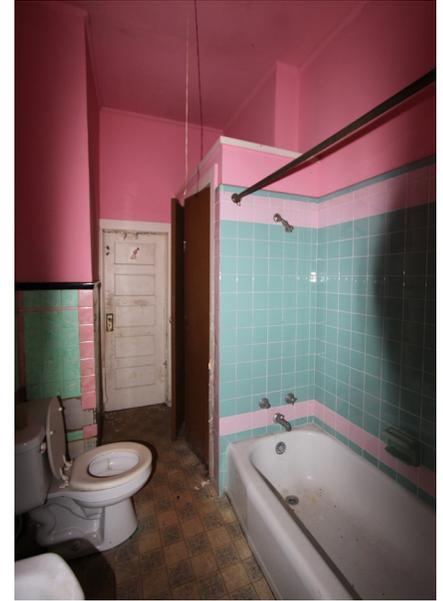
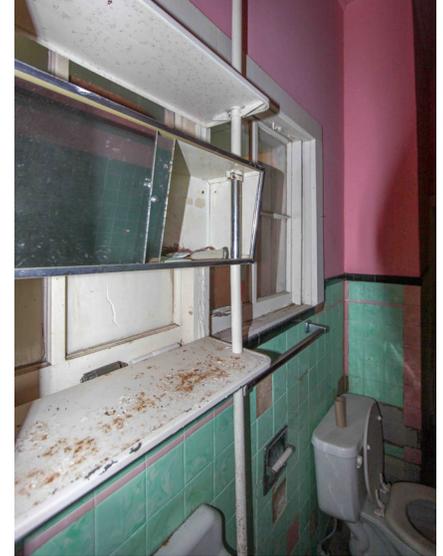
Bath B Current Conditions

Images of the current condition of Bath B. Note the low closet (above) and the interior window set behind the mirror and shelves (below).

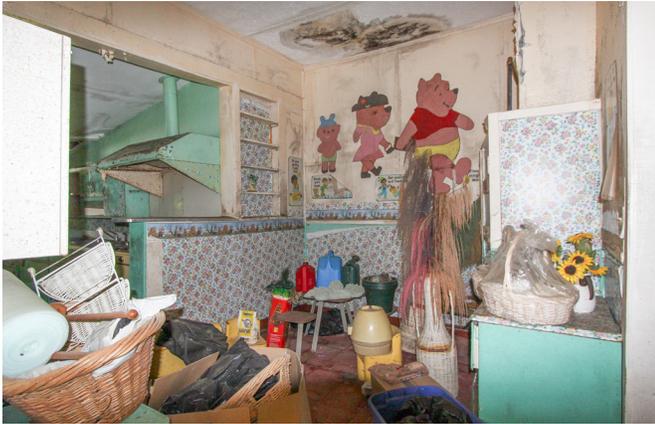
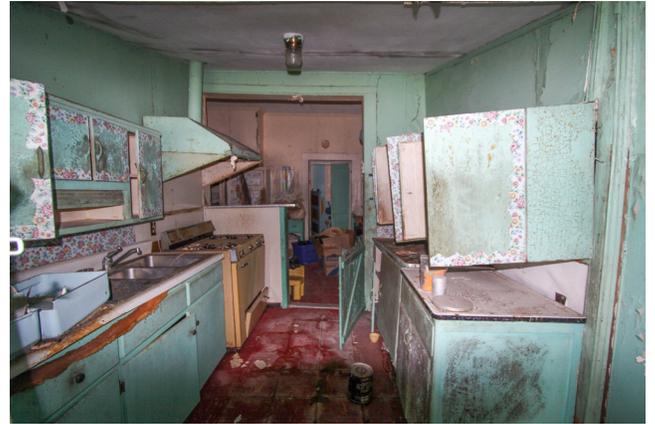
Breakfast Room and Kitchen Current Conditions

Breakfast Room (left) and Kitchen (right) current conditions. Note the ceiling leak in the Breakfast Room and the low ceiling and period cabinets and stove in the Kitchen.

The Kitchen has an **asbestos tile floor** that is in fair condition, matching adjacent spaces. As seen in the space's southwest corner, an earlier **vinyl floor** stamped to read as tile is

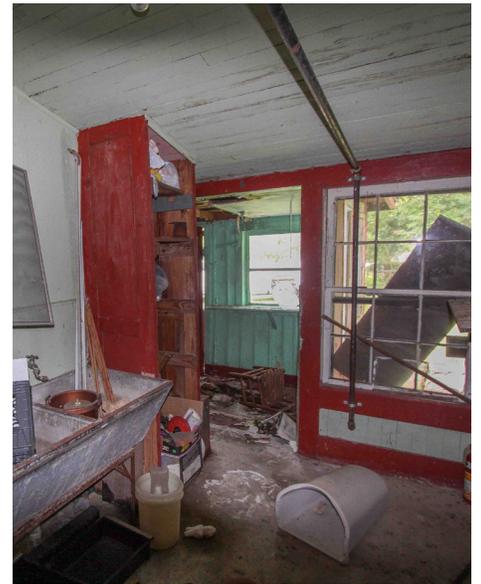
Rear Porch Current Conditions

Images of the current condition of the Rear Porch. Note the original front door that has been repurposed here and the board and batten walls.

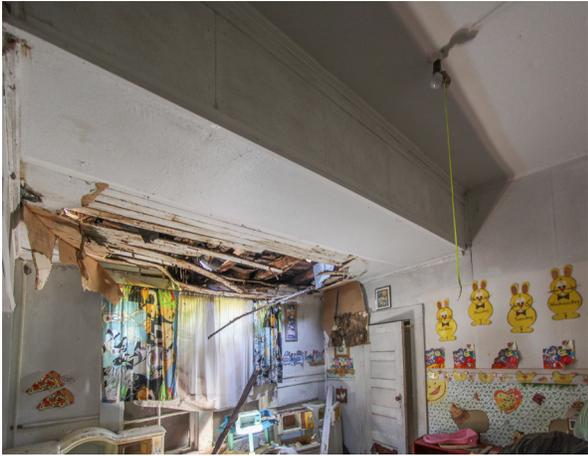
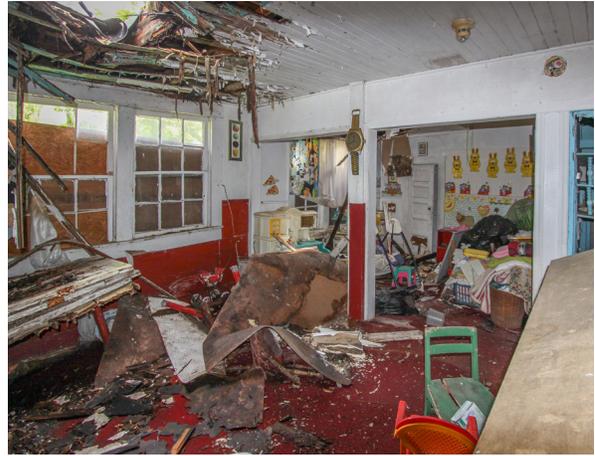
Roof Leak Deterioration
 (Above) Images of the current condition of the joint Delivery and Recovery Room B spaces.

- Replace the existing vinyl flooring in-kind with

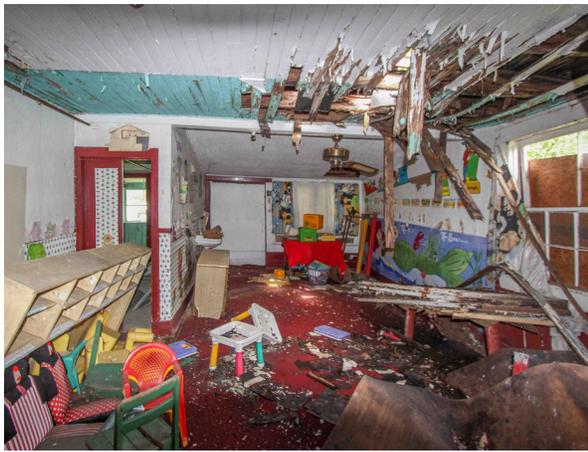
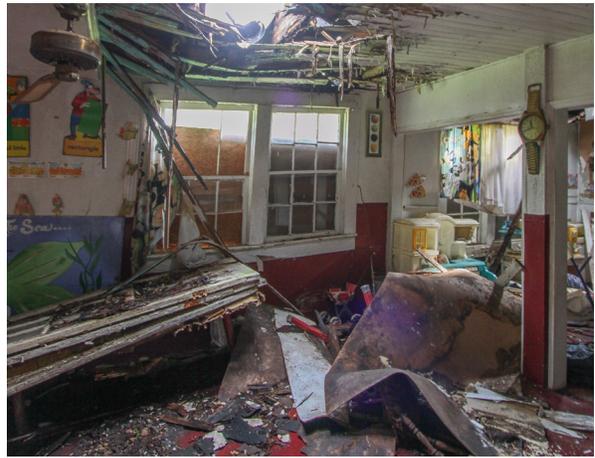
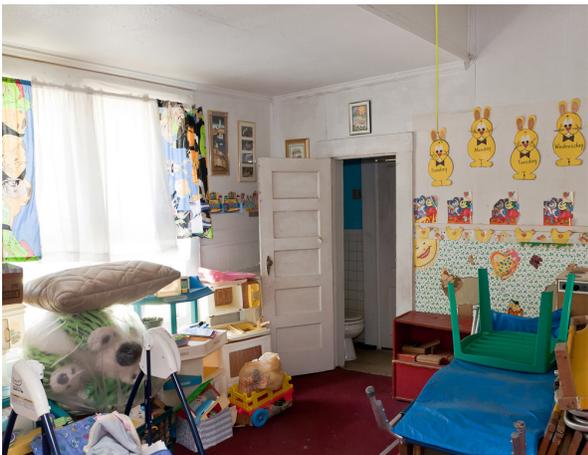
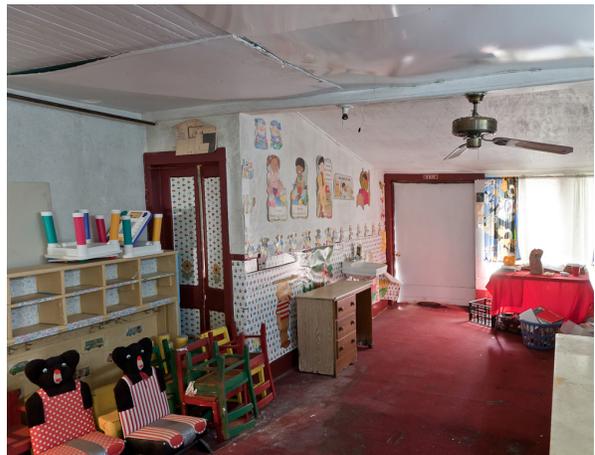
Before Photos
 (Below) These images show what the Delivery and Recovery Room B spaces looked like in 2010 prior to damage.

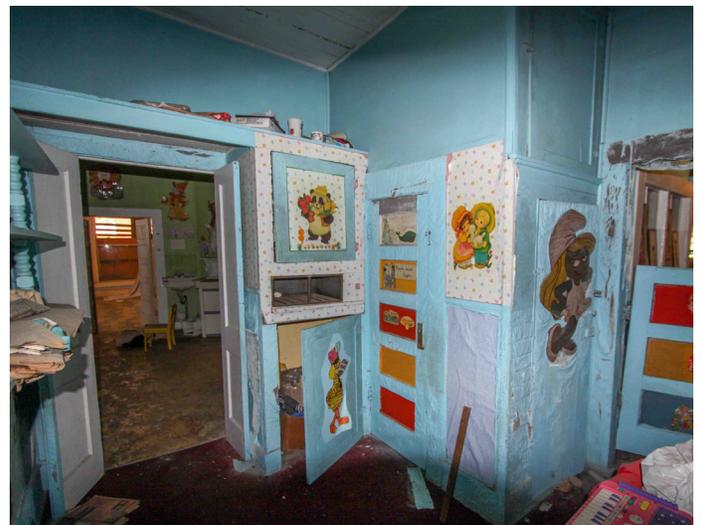
Circulation Area

Images of the current condition of the Circulation area. Note the daycare paint scheme and the space's many closets.

- Remove wall-to-wall carpet and examine flooring set beneath. If vinyl, either restore or replace with period appropriate vinyl equivalent
- Paint all walls and wood surfaces

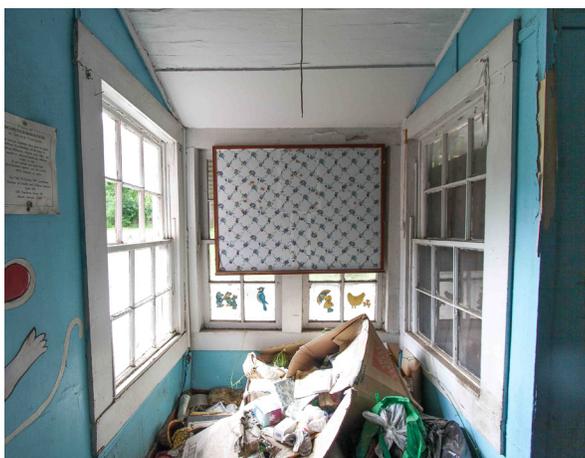
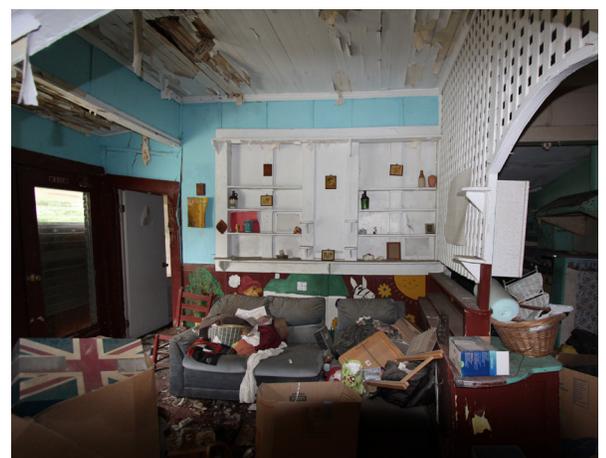
The room has an **asbestos tile floor** that is unsound as evidenced in significant sagging associated with deteriorated floor framing beneath. The space has **sheetrock walls** framed by wood battens, all of which is painted and the space has **wood baseboards** and **door and window trim**. Children's character mural paintings exist throughout the space from the daycare era. On the east wall, an **attic access hatch** exists, where it is possible to access the space above Bedroom C. The room has a **tongue and groove ceiling**, which is painted. Roof leaks have led to significant damage, particularly adjacent to the south entrance. The ceiling features a **header** at the southern end of the room, revealing where the ca 1940 room may have been extended ca 1965. On the north wall, a low wall with **wood lattice** above separates the Breakfast Room from the Lobby.

Images of the current condition of the Lobby. Note the added sunroom space (first), the former exterior window opening (second), and ceiling leak (third), and the wood lattice partitions (last).
